## FIELD INSPECTION

<b>Project Name:</b>	Mountain Valley Pipeline	<b>Inspector:</b>	Matthew Grant
<b>Inspection Date:</b>	Thursday, September 26, 2019	<b>Project Contact:</b>	Brian Clauto
<b>Spread: Montgomery Co. AR MN 278.01 MP237.3-235.7</b>	Spread H	<b>Weather (Wet/Dry/Rain):</b>	Dry

## FIELD INSPECTION PHOTO LOG

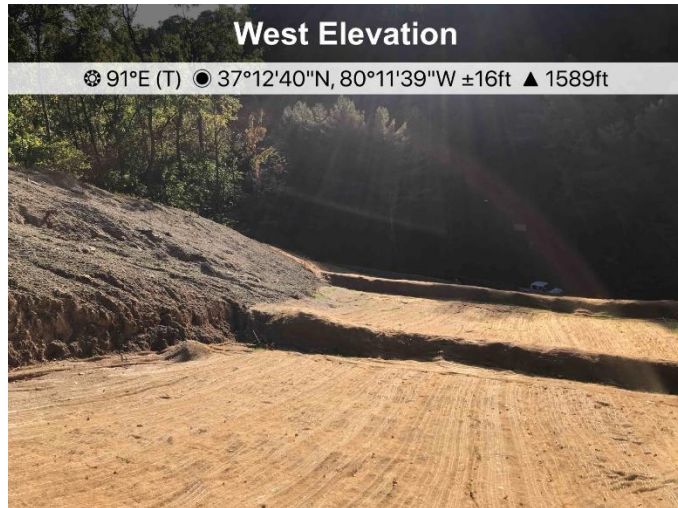
- Fig. 1 Slope leading to AR MN278.01 has been stabilized with matting.

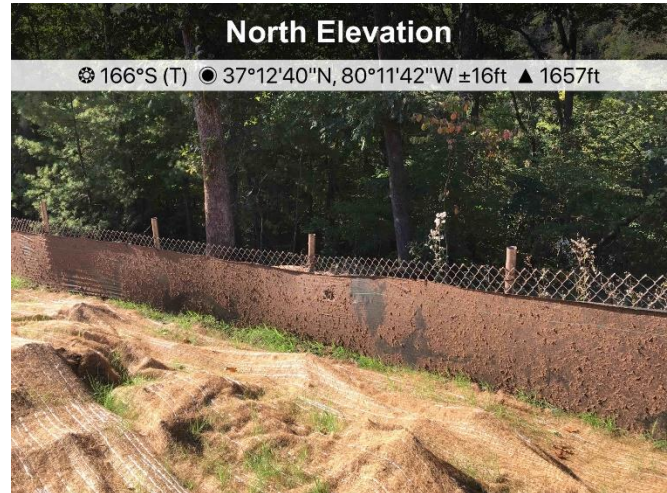
- Fig. 2. St12539+15 SSF has a hole in it and requires maintenance.

**Recommend Corrective Action:** Maintain and install all controls per the approved plan and specs

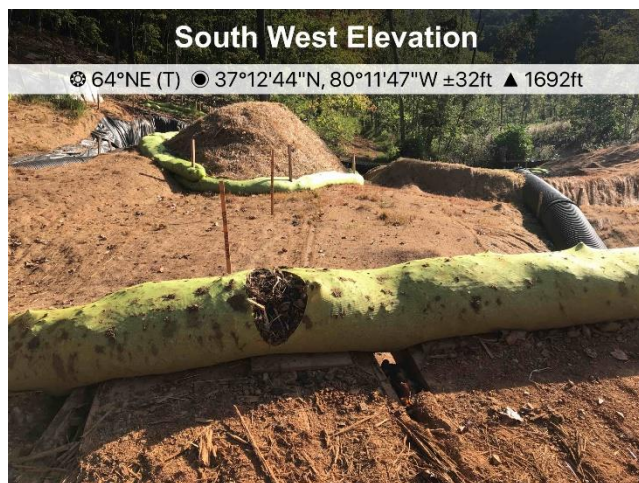
- Fig. 3 St12533+62 CFS has a hole in it and requires maintenance.

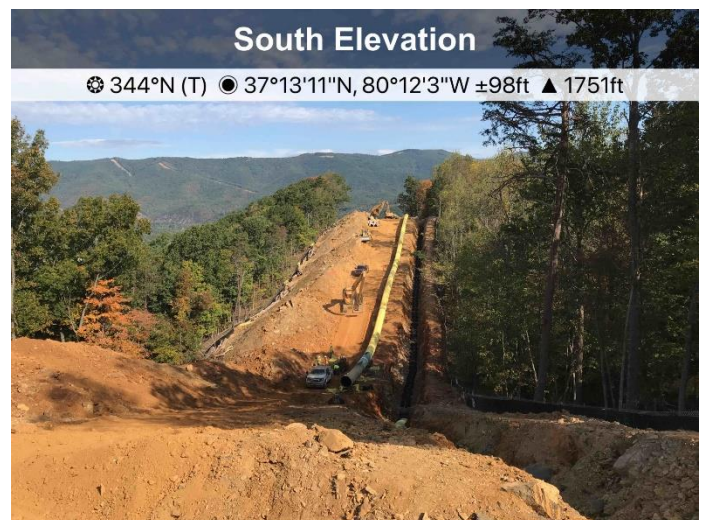
- Fig. 4 St12496+00 pipe is being rock guarded.
